**LEYDEN ROCK METROPOLITAN DISTRICT  
SPECIAL MEETING**

# LEYDEN ROCK

Prepared for: Ms. Katie Call

MAY 4<sup>TH</sup>, 2023

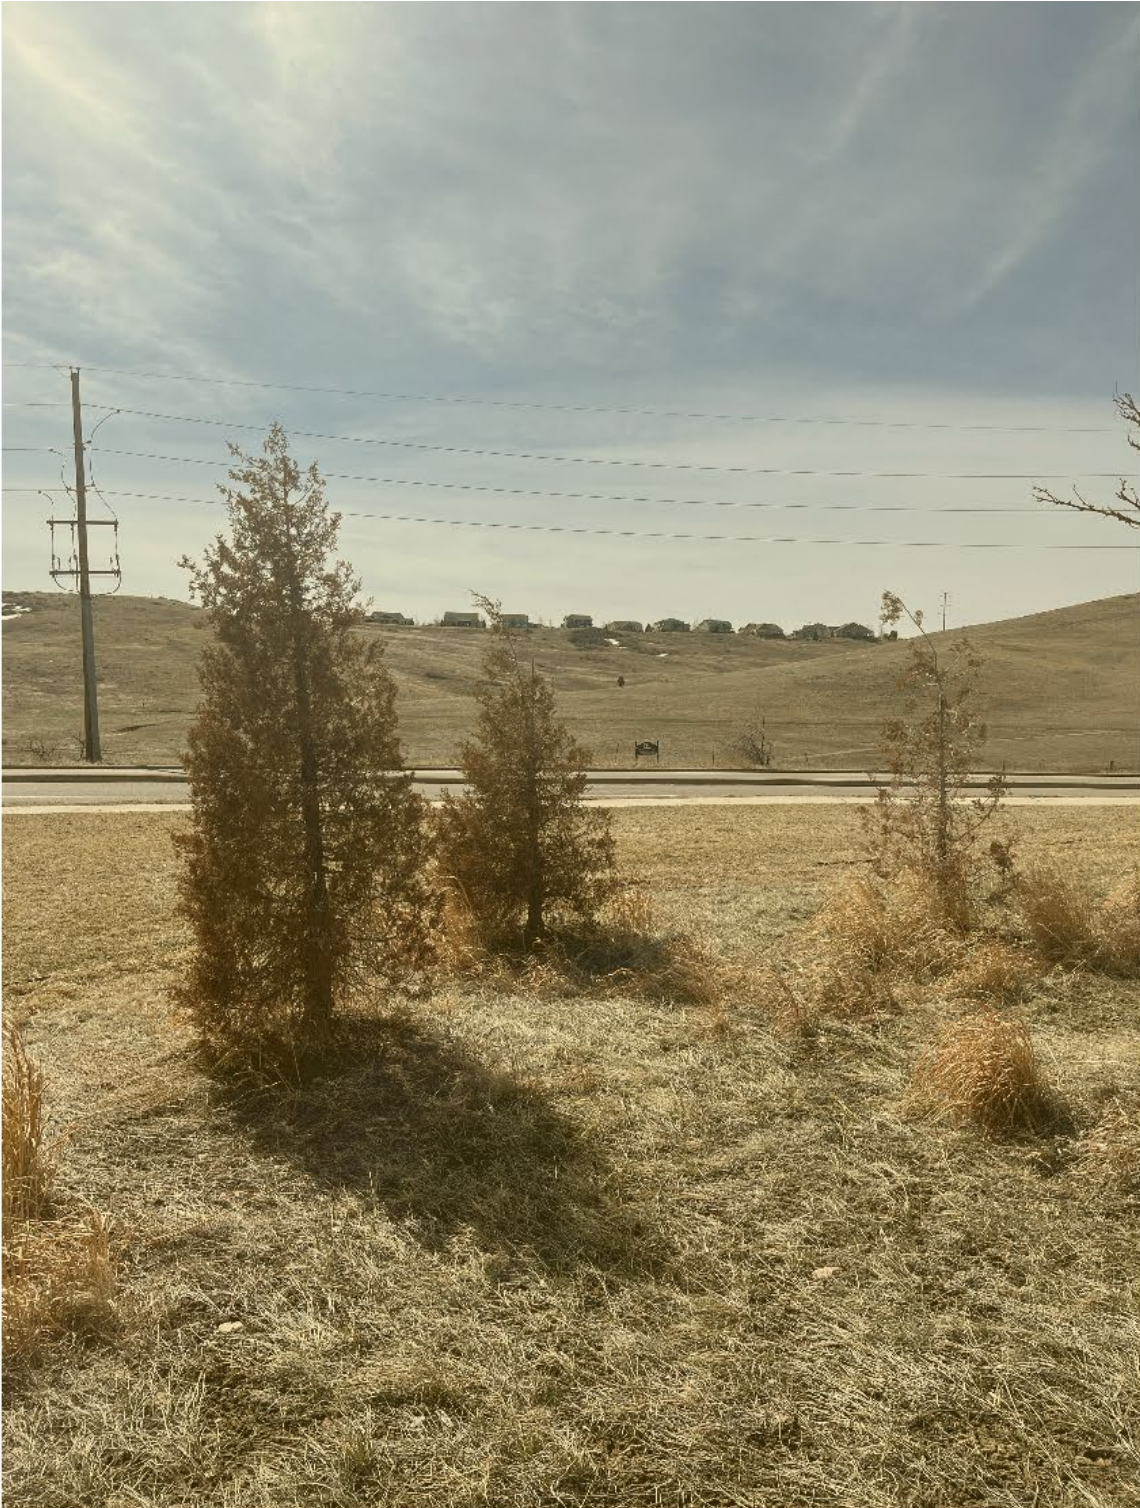
Additionally, while the majority of the trees on-site appeared to have irrigation set up to them at some point, some irrigation appeared to be in poor repair (Photo 9), missing altogether, or on improper scheduling (Photo 7). Proper watering is the first step in proper tree care, and in Colorado with our low annual precipitation, that involves proper irrigation set up. The lack of proper watering and water retention is evidenced by the browning of needles on many of the evergreen trees, a symptom known as **winter desiccation** (Photo 1 and 4).

**Photo 1: evidence of desiccation**

- b. Perform **anti-desiccant** sprays twice a year between November and March.
  - c. Perform biannual fertilizations of the community trees.
  - d. Perform a water test of the irrigation water to understand the pH and makeup of the water being applied to the plants on-site.

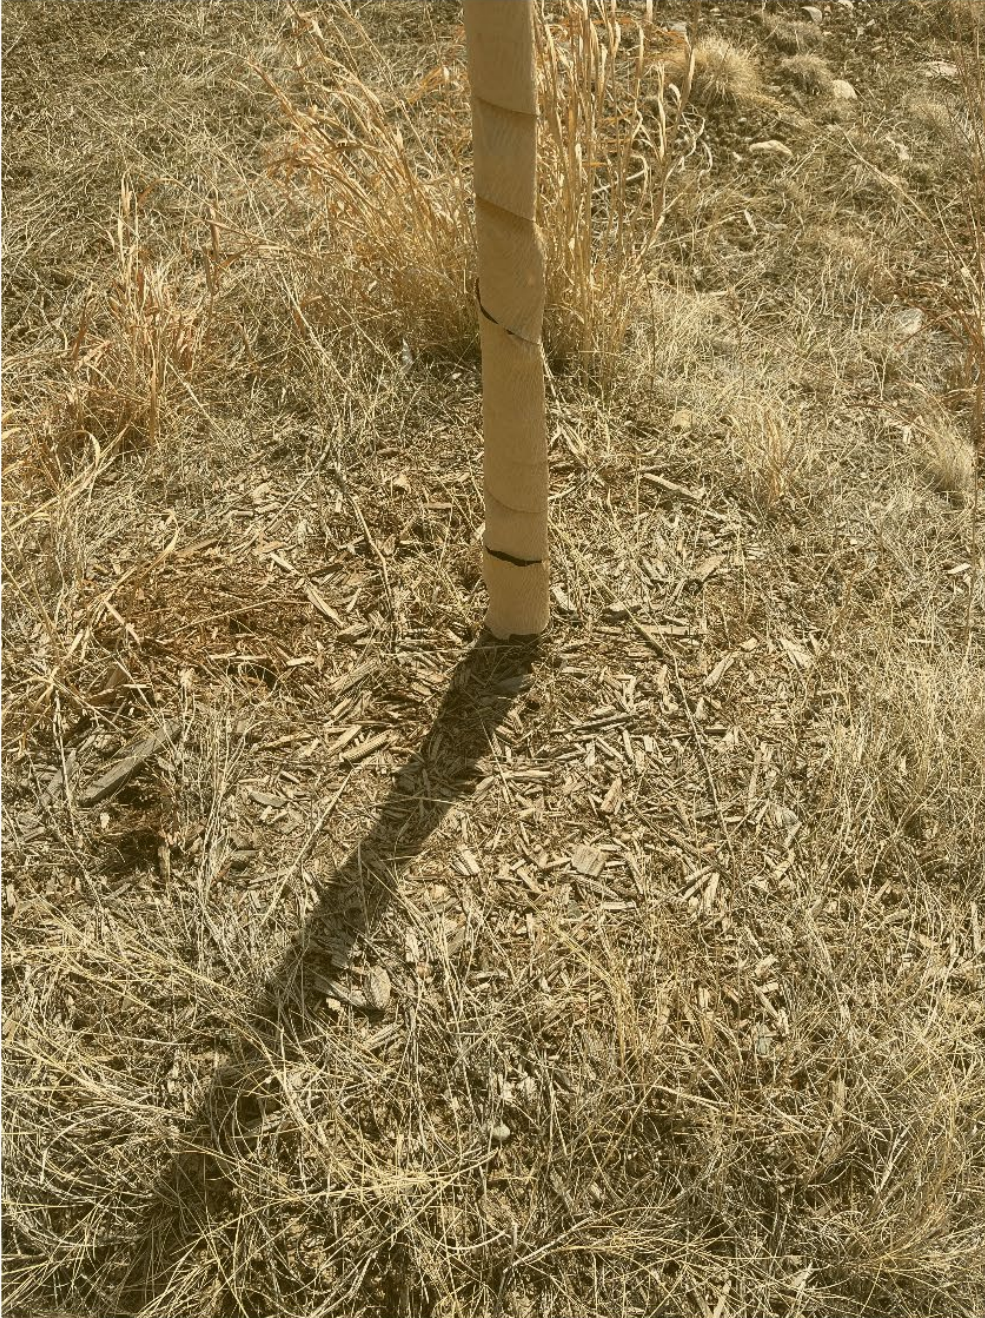
While many of the trees on site appeared to be planted at the correct depth and had nice berms set up to help with water retention, there was some evidence of some poor planting practices. One such practice is planting too deep, or inappropriate planting depth (photo 2). Poor planting depth is often indicative of other poor planting practices such as leaving twine and cages intact upon installation. Twine and cages can cause trees to become **root bound**. These trees may also develop **girdling roots** that can eventually result in poor canopy development or even tree death. Additionally, several trees had tree straps used in the planting process to stabilize the tree left on too long. These tree straps become embedded in the tree, often girdling stems or trunks (Photo 3 and photo 6).

**Photo 2: Planting depth issue**

- e. Utilize an **Air Spade®** or similar tool to mitigate the soil compaction under trees exhibiting signs of stress, poor planting, or root issues. This can be done by **radial trenching** within the root zone or a comparable technique. The air tool limits root damage while still allowing for adequate excavation. The areas spaded should be back filled with a combination of native soil and **amended topsoil**.

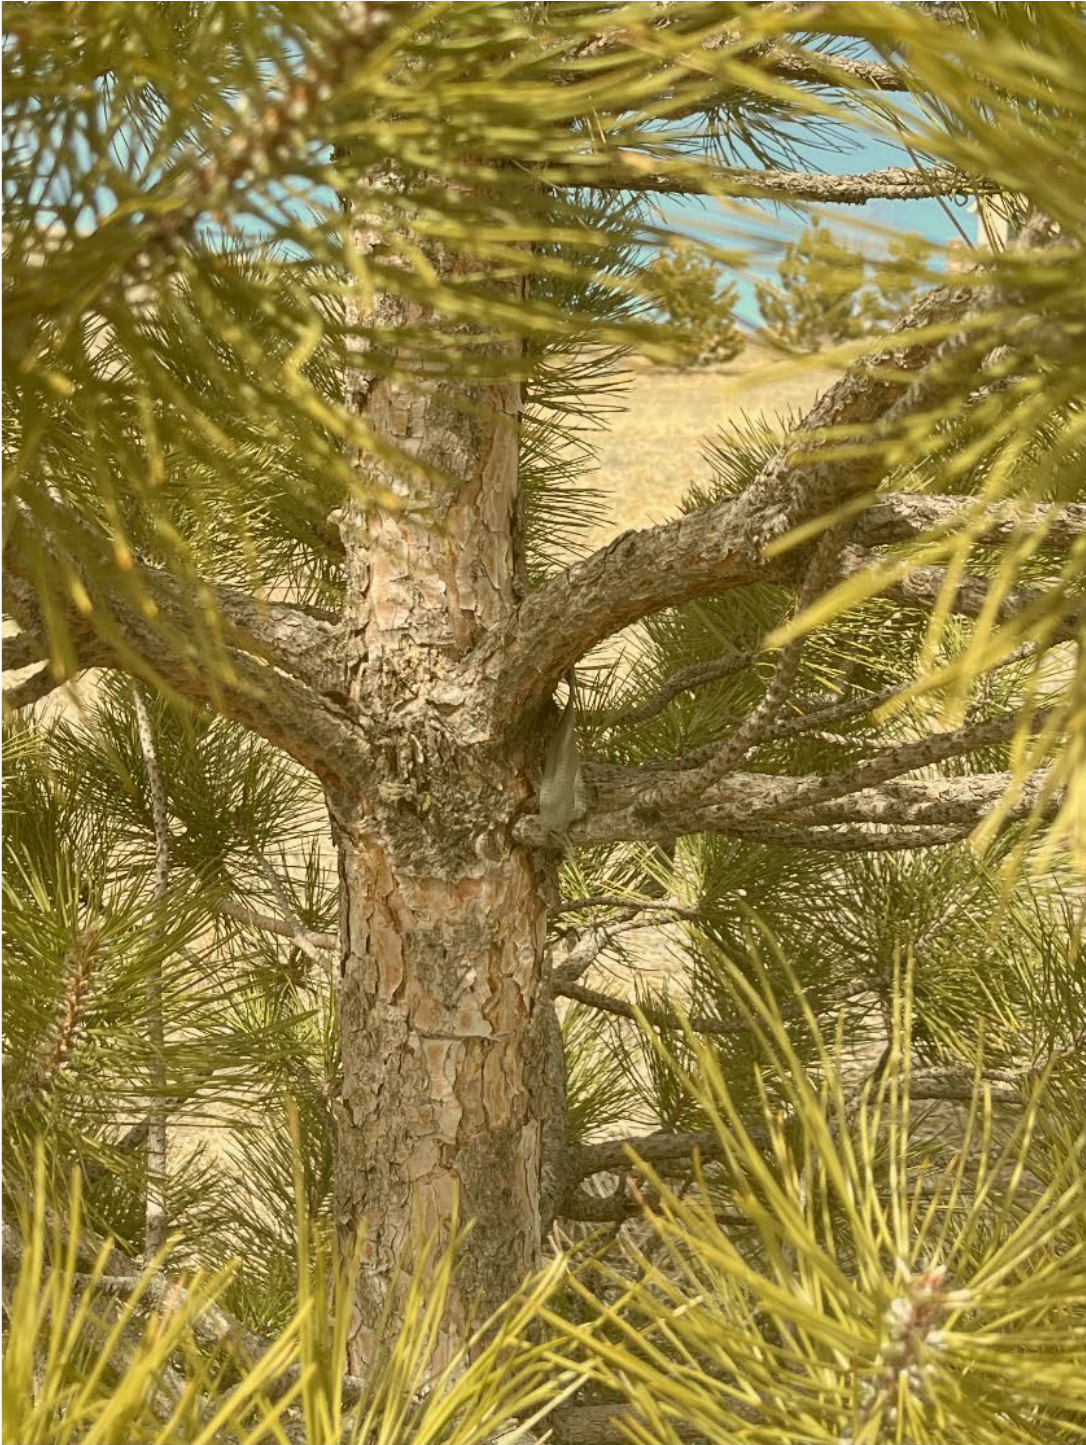
**Photo 3: tree straps left in tree**

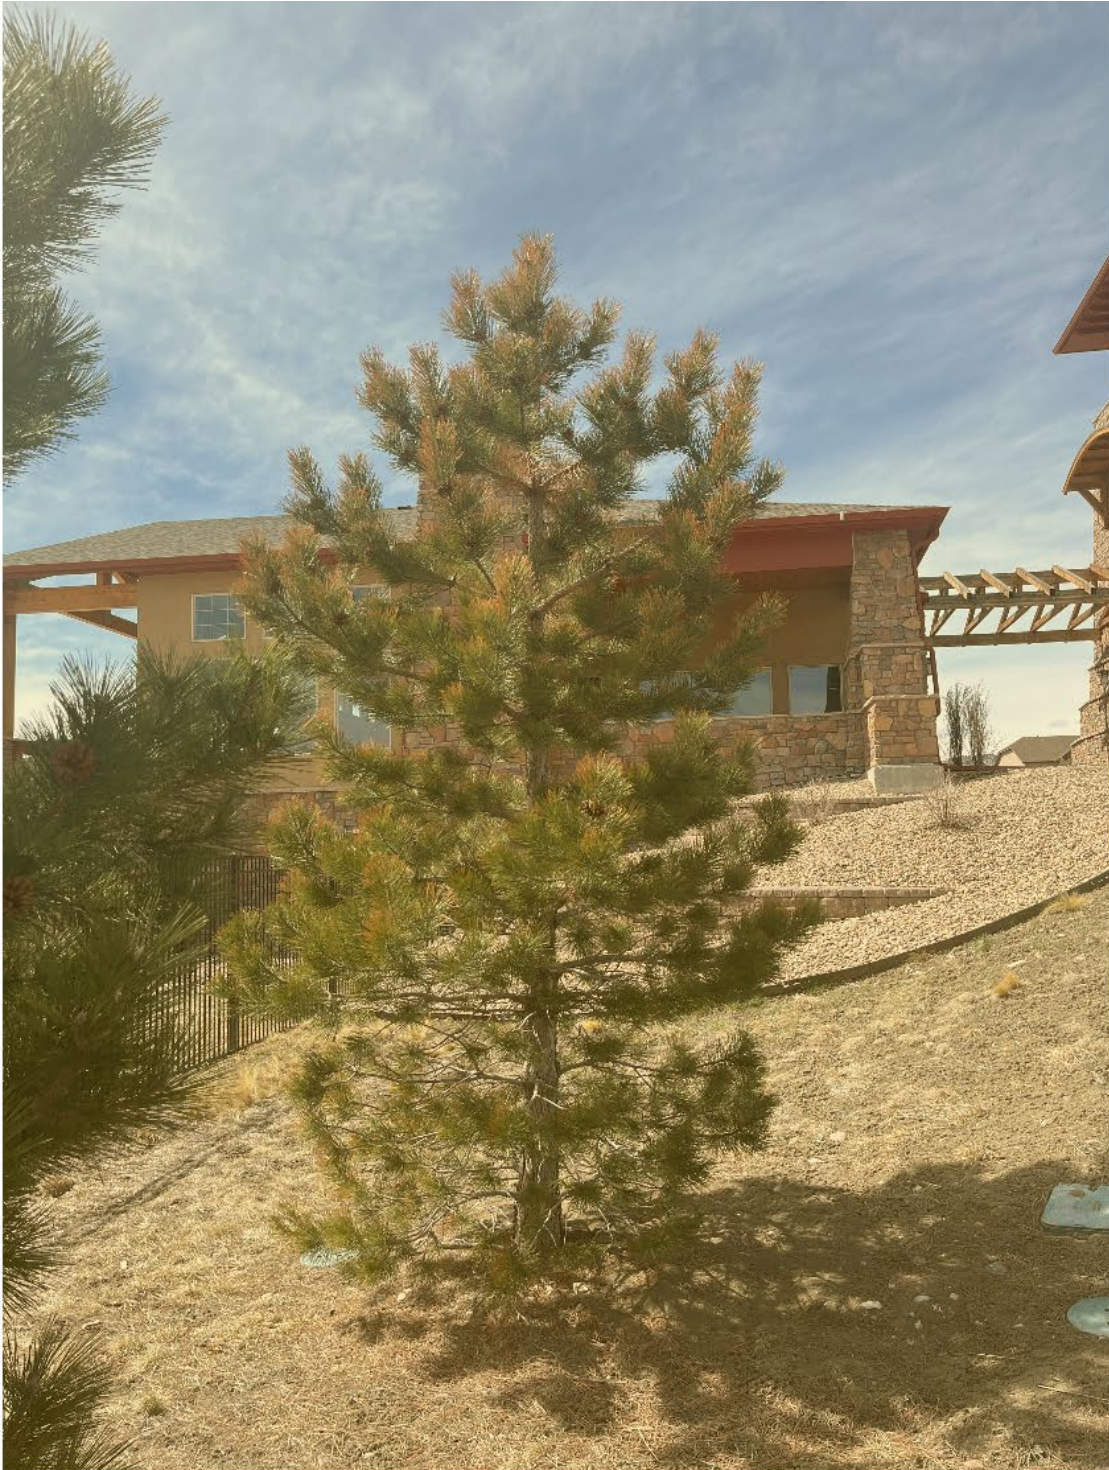
**Photo 4: additional desiccation evidence**

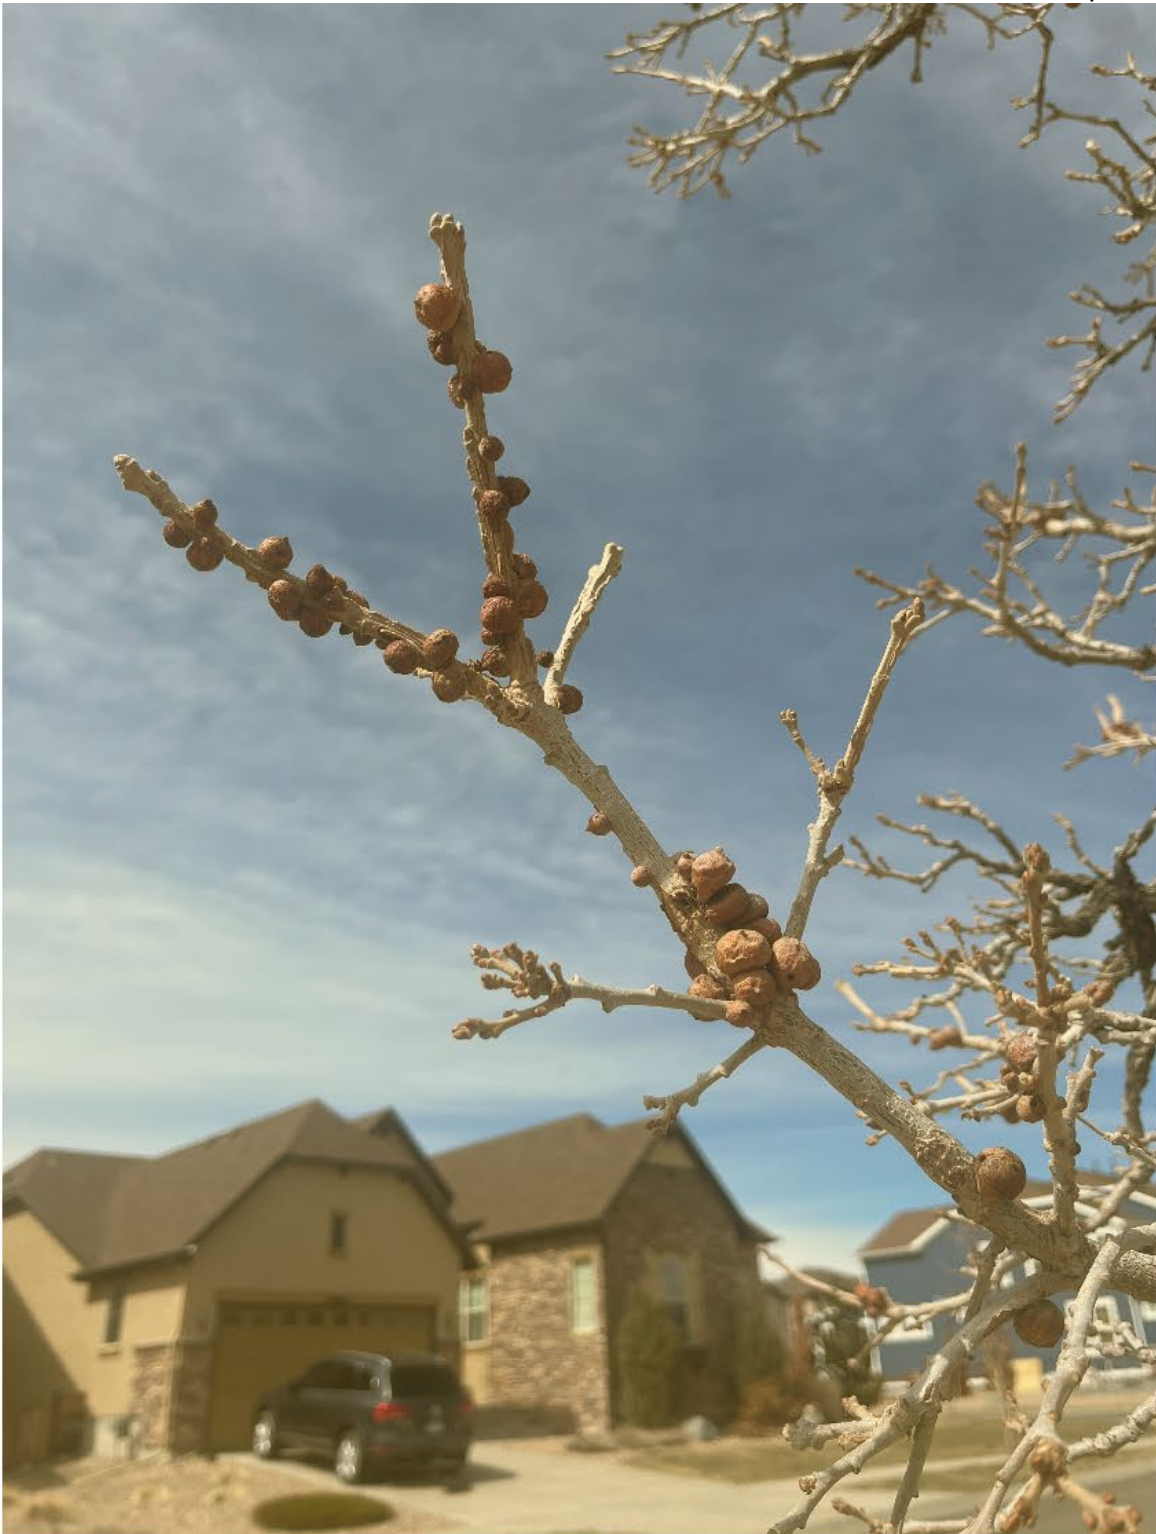
Some of the bur oaks on-site exhibited signs of Rough Bulletgall Wasp (*Disholcaspis quercusmamma*) (Photo 5). These insects produce a woody, generally rounded gall on bur oaks. **Sooty molds** may grow on the gall as they age. The stubby-bodied brown wasps are only present in the late October/early November timeframe when they emerge from the gall and oviposit in the dormant buds. The insect only causes minor injury to the plant as heavy infestations can stunt the growth of twigs. The honeydew residue left by the wasps may also attract nuisance insects like other wasps or bees. There are no insecticidal controls for this insect, but there are several species of parasitic wasps that act as natural enemies (*Rough bulletgall WASP - Colorado State University 2022*).

**Photo 5: bullet gall in bur oak**

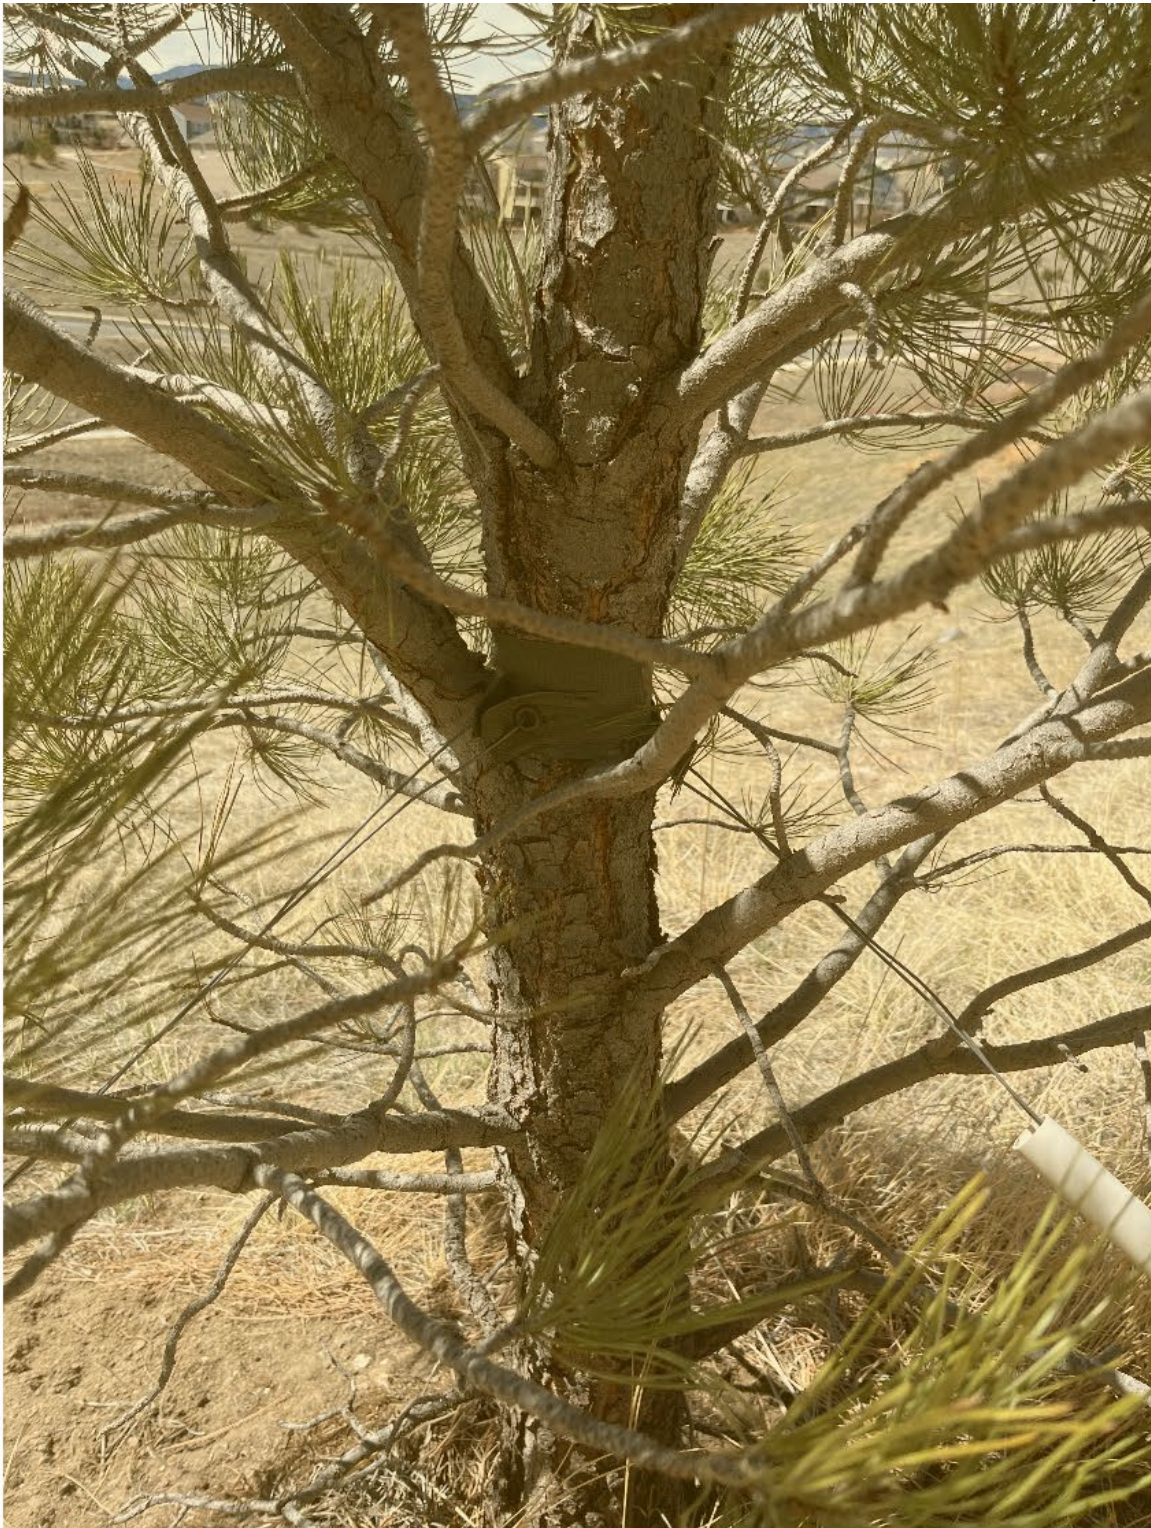
**Photo 6: Further girdling evidence**

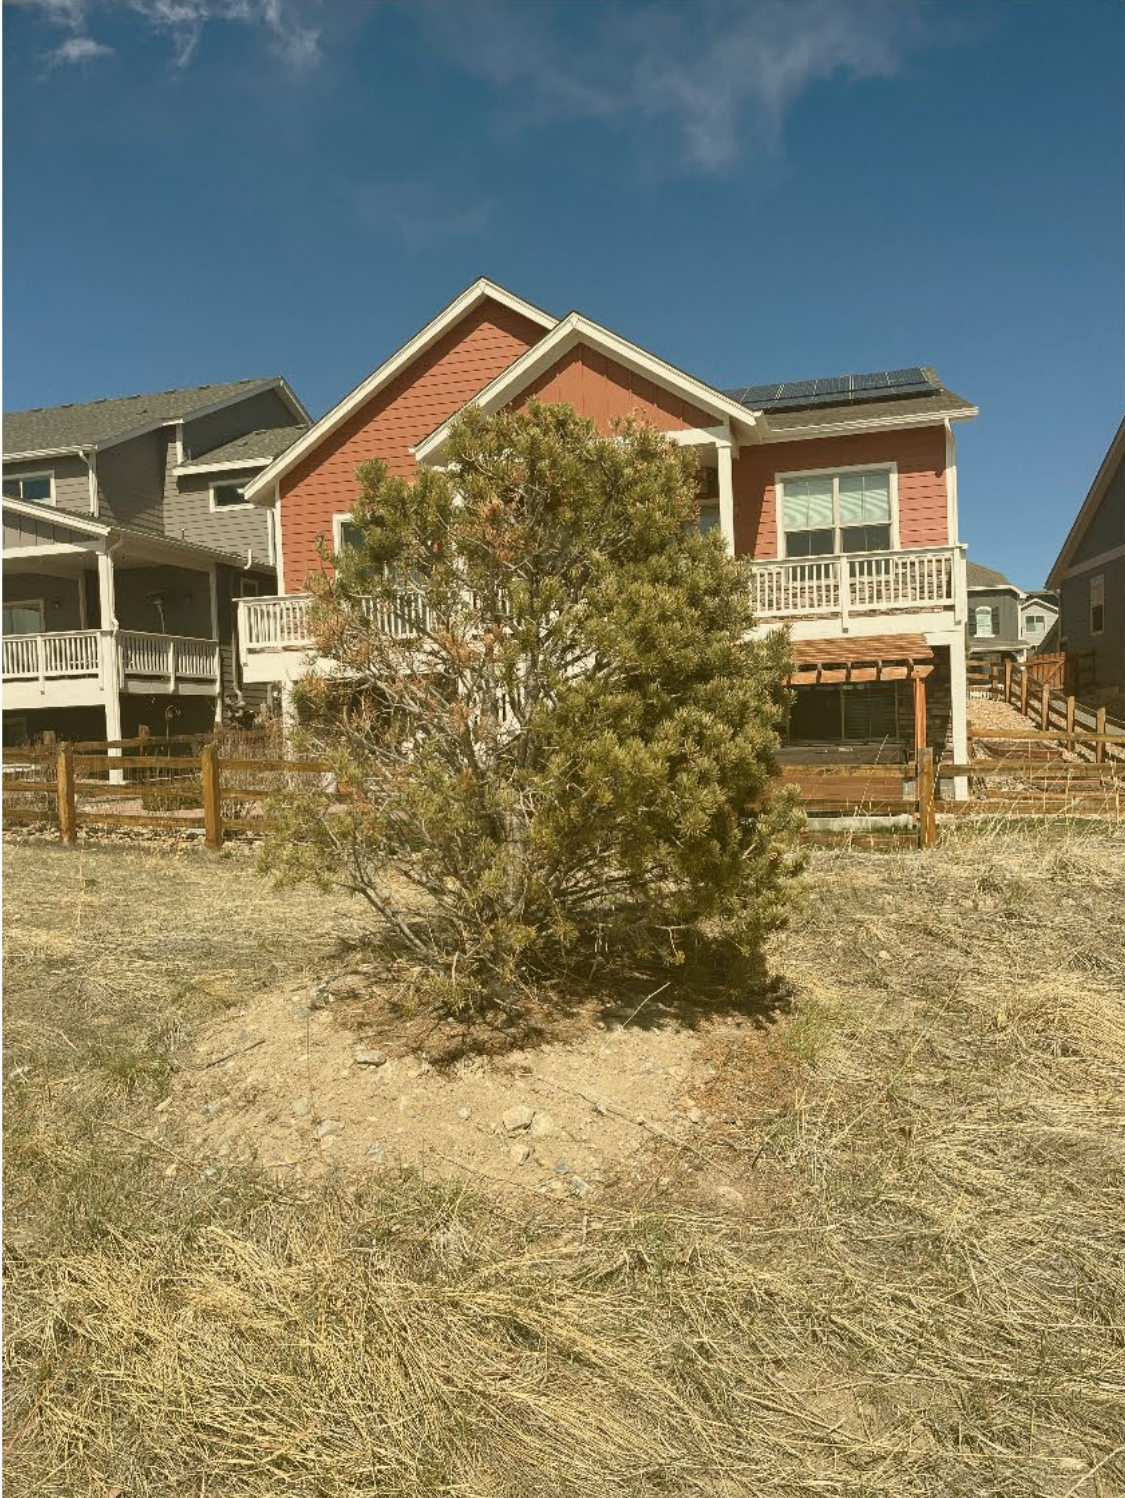
Based on the results of this sampling, the **organic material** is low, the pH is high, nitrates were low, and the soil composition is sandy loam, clay loam, and sandy clay loam (Taddekin Report, 2021). These results are evident from a surface level given the color, texture, and moisture level (photo 7). As noted in the report, these results generally indicate a need to increase water intervals but a reduction of amount of water to allow for proper drainage and biannual fertilizations to assist with building soil health over time.

**Photo 7: Drought and possible planting issues**

- b. Hire a professional irrigation service or landscape professional to audit the irrigation system. Ensure that the irrigation is in working order for all trees, and the program allows for adequate water to each tree. This system will need to be monitored and adjusted regularly during the growing seasons to ensure that trees are getting the appropriate amount of watering based on site specific soil conditions.

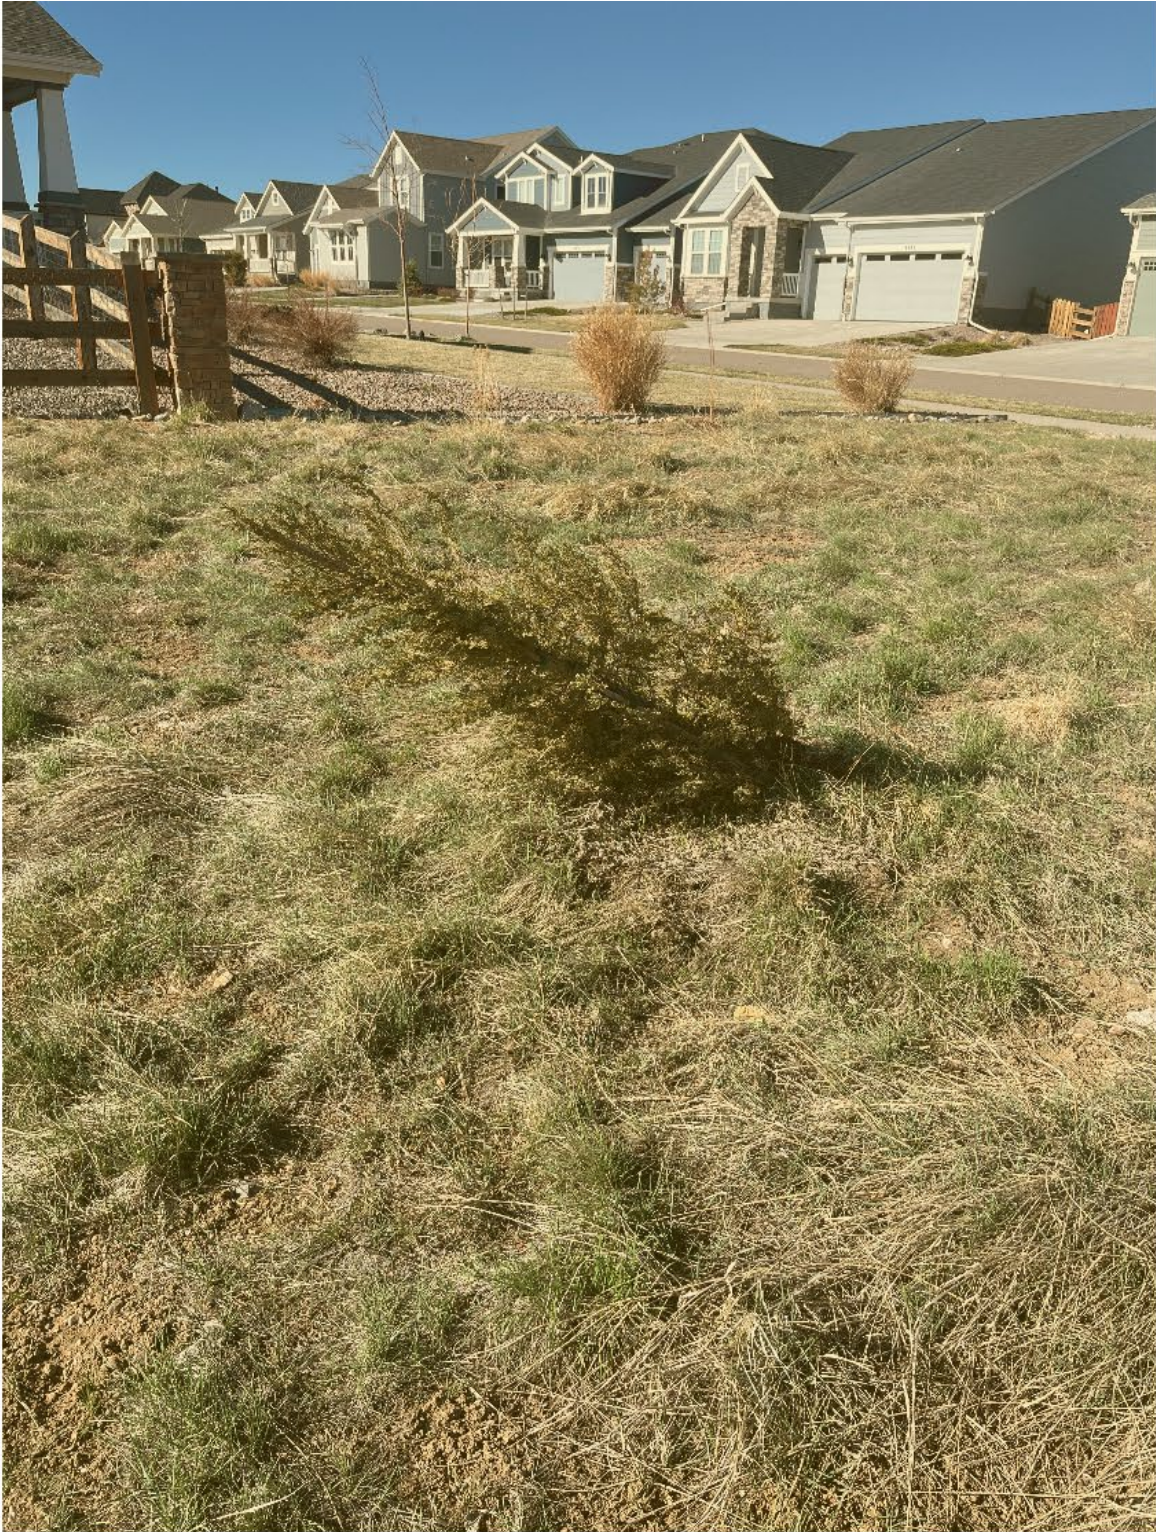
**Soil compaction** occurs when pressure is placed on the soil causing a reduction in available oxygen to the root zone as those pockets of air are compacted and eliminated. Compaction can occur when equipment is driven over or parked on the root zone, or even from heavy foot traffic over the root zone. Given that the root zones for many of the landscaped trees here are impacted by either a path or a road, there is good evidence that the soil is compacted in these areas. Compacted soils make it difficult for roots to penetrate, thus limiting root growth. If root growth is limited, then **anchorage** will also be limited – leading to less stable trees as the canopy expands and the forces applied to the roots are increased by weight and wind. Given the trees are generally planted in groups, anchorage likely will only be an issue for isolated and exposed trees (photo 8).

**Photo 8: uprooted juniper to re-stake**

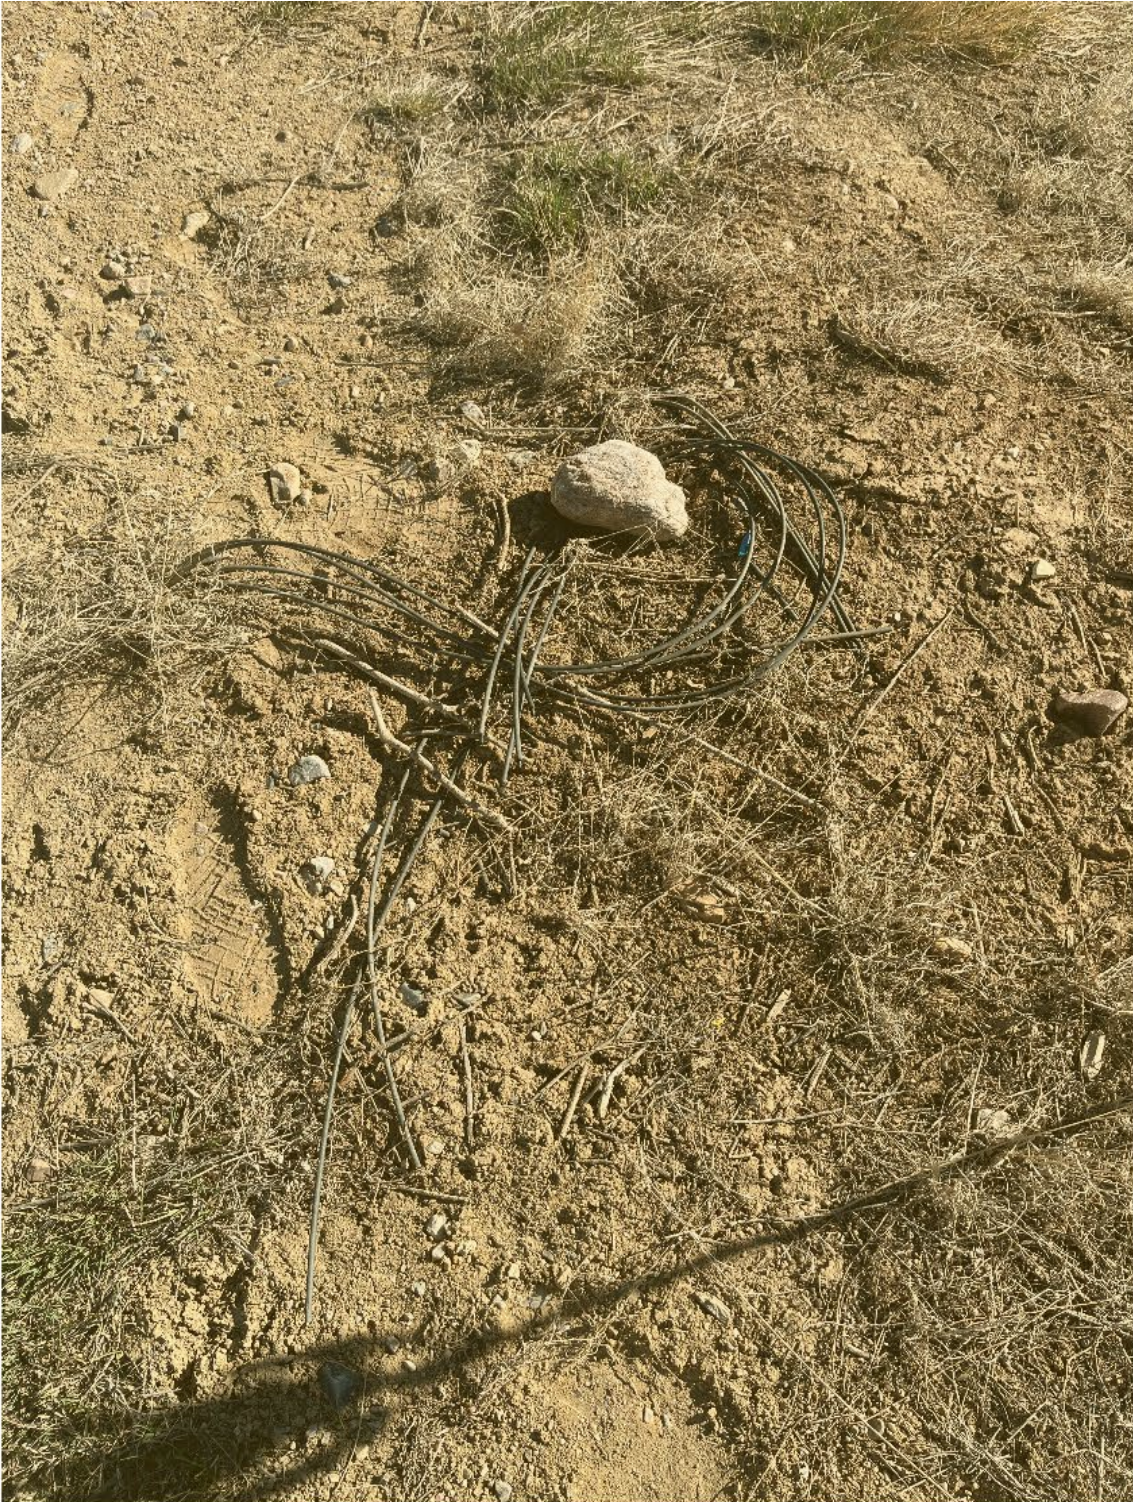
**Photo 9: Evidence of irrigation in disrepair**

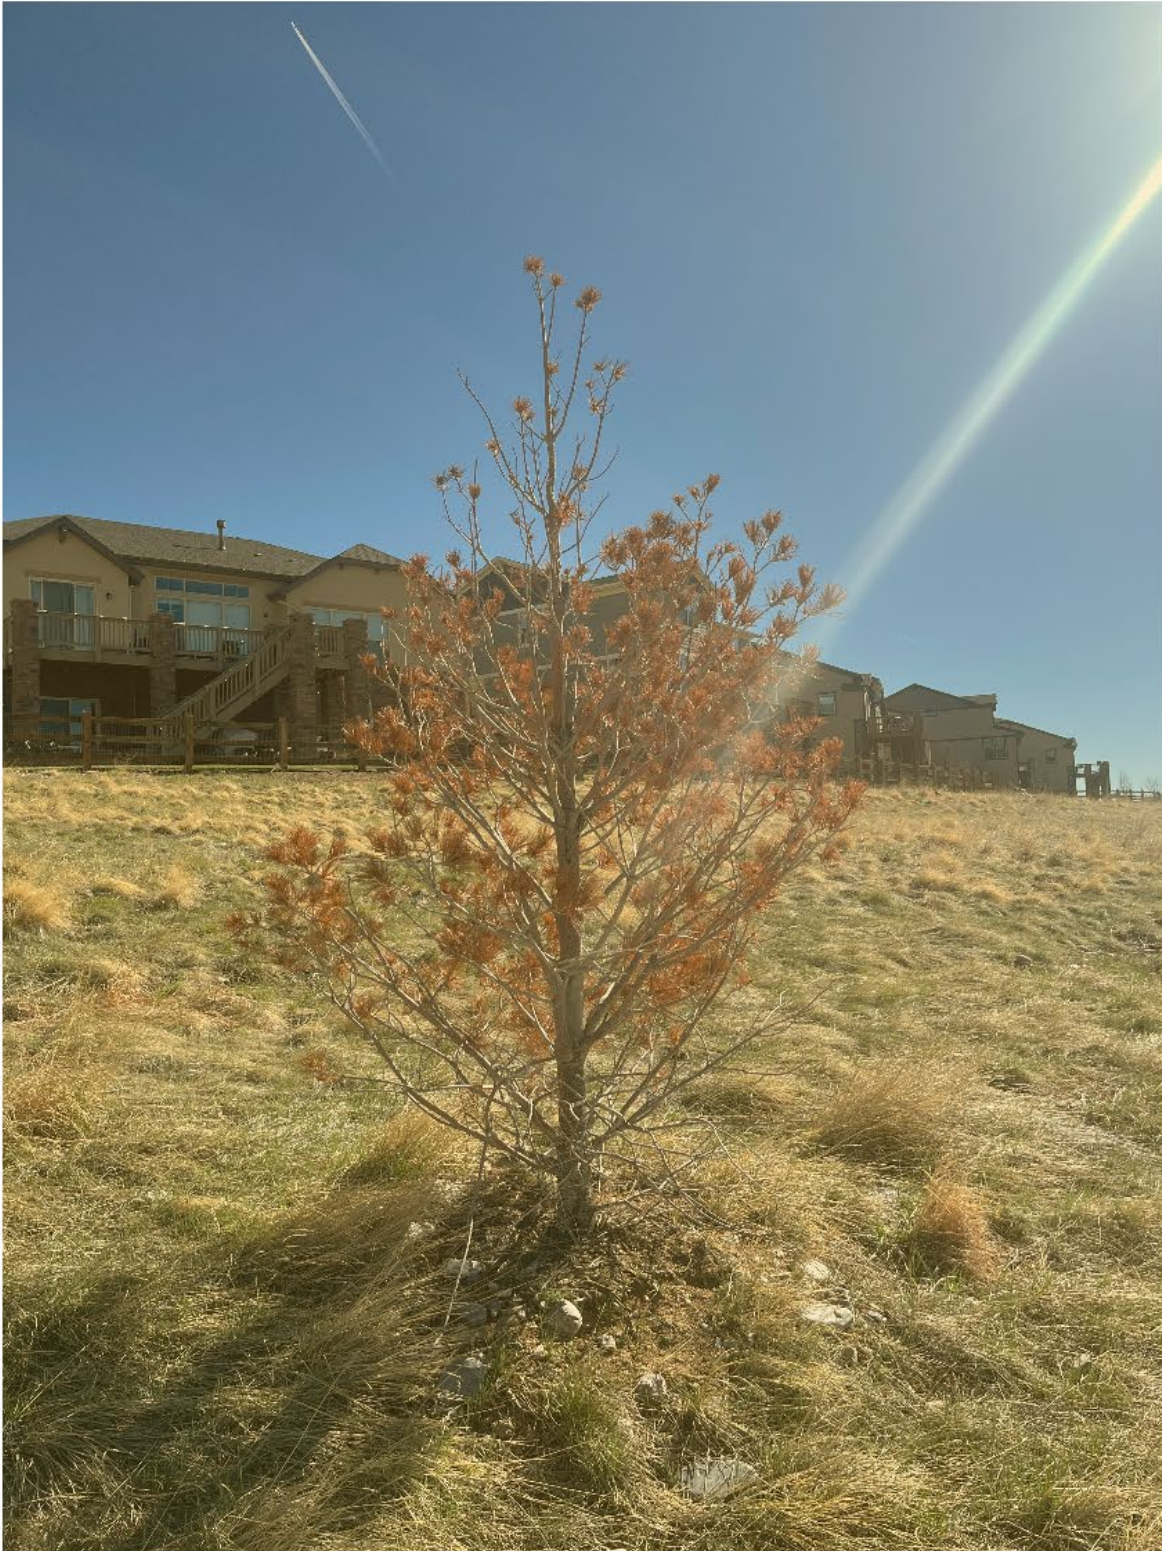
Water quality, specifically as it pertains to the water's **pH** may be an issue here. Denver Water has recently increased the pH of the water it provides to average 8.8, up from 7.8 previously (2022, *Adjusting the pH in Drinking Water*). Thus, the water is now ten times more **alkaline** than it was a few years ago. This shift in pH seems to particularly negatively impact the Colorado blue spruce, as it prefers a more neutral to slightly alkaline pH – 6.8-7.2 (Fechner, 2022). Anecdotally, it appears that the white pine may be adversely affected by the higher pH water (photo 10).

**Photo 10: most white pines are dead or declining here**

- g. Remove and replace the 149 trees in the poor to very poor category of health rating. Replace trees with species appropriate for the site and soil conditions. Remove white pines and hackberries from the planting list. Increase species diversity to mitigate the risk of pest and disease outbreaks compromising large portions of the forest.
